Field test of hydrogen in the natural gas grid

EFP05 J.nr. 033001/33031-0053

**Project Report
August 2010**

Title : Field test of hydrogen in the natural gas grid, EFP05 J.nr. 033001/33031-0053

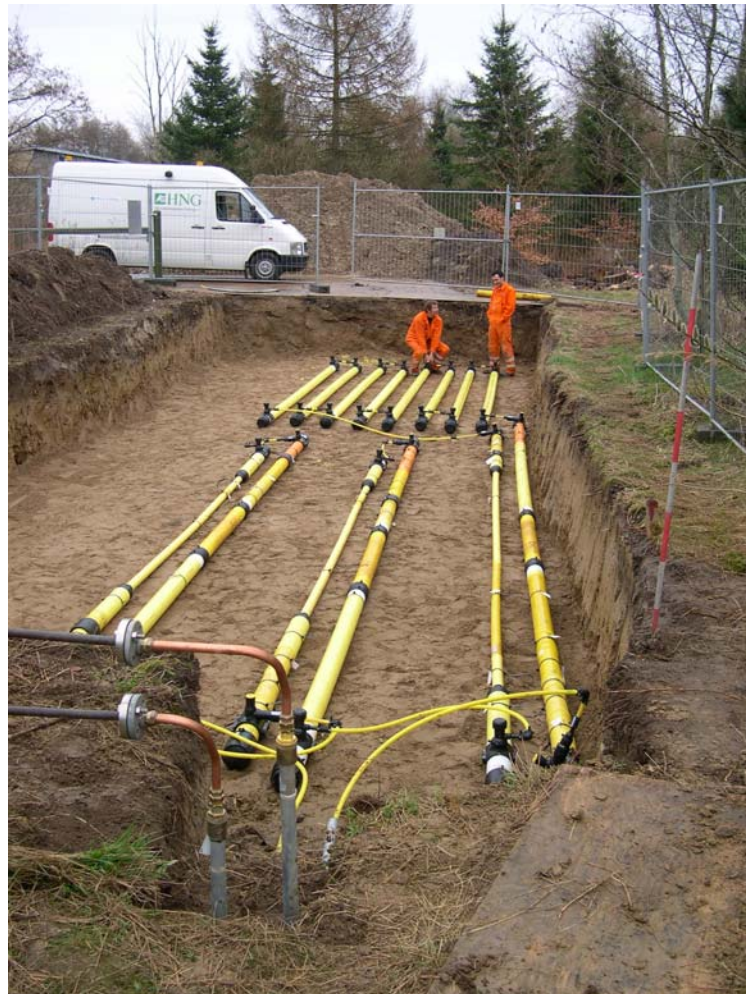
During the test phase the polymer pipes were exposed to pure hydrogen continuously for four years. The pressure was around 4 barg and the temperature around 8 °C. The pipes were placed as a normal gas distribution grid. See Figure 1.

Figure 1 Polymer test pipe grid

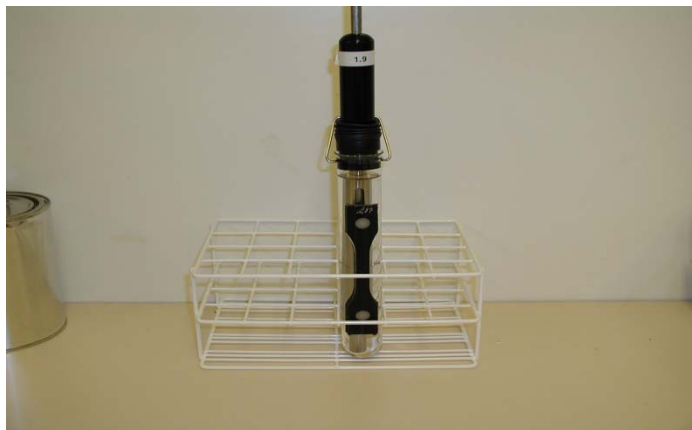
Slow crack growth CTL, ISO 6052-1992, Notch acc ASTM F1473

Figure 2 Surface-active solution, Igepal CO-720 at 60 C, stress level 5,0 MPa.

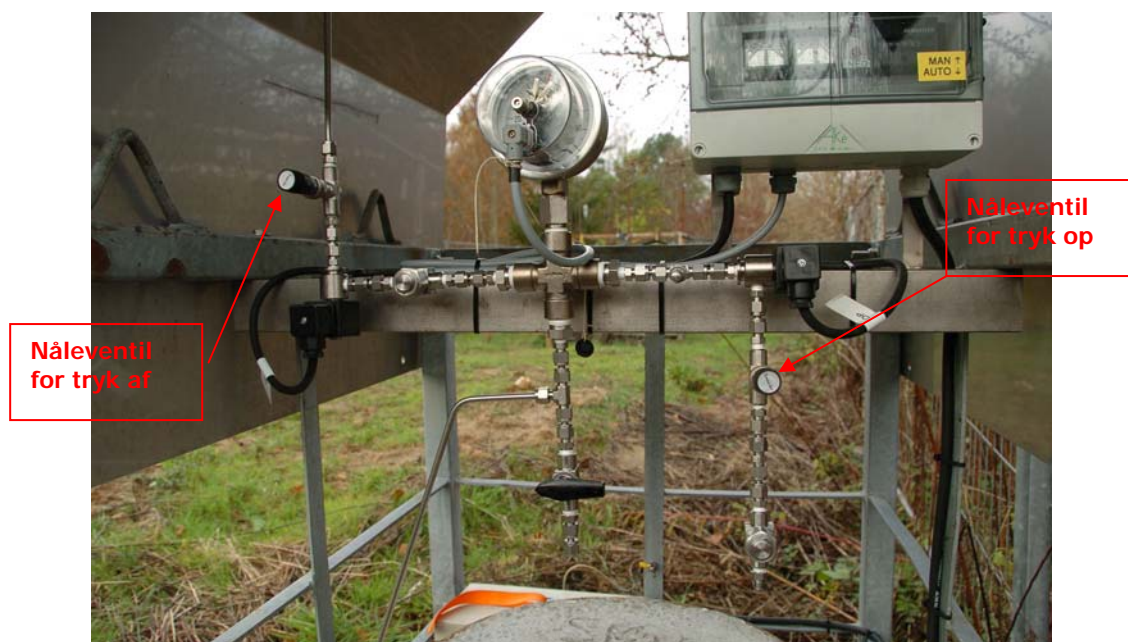
Trykstignings- og tryksænkningshastighederne reguleres med drøvleventilerne 1 og 5. Foto nr. 1 og 2 viser testopstillingen i sin helhed og i detaljer.

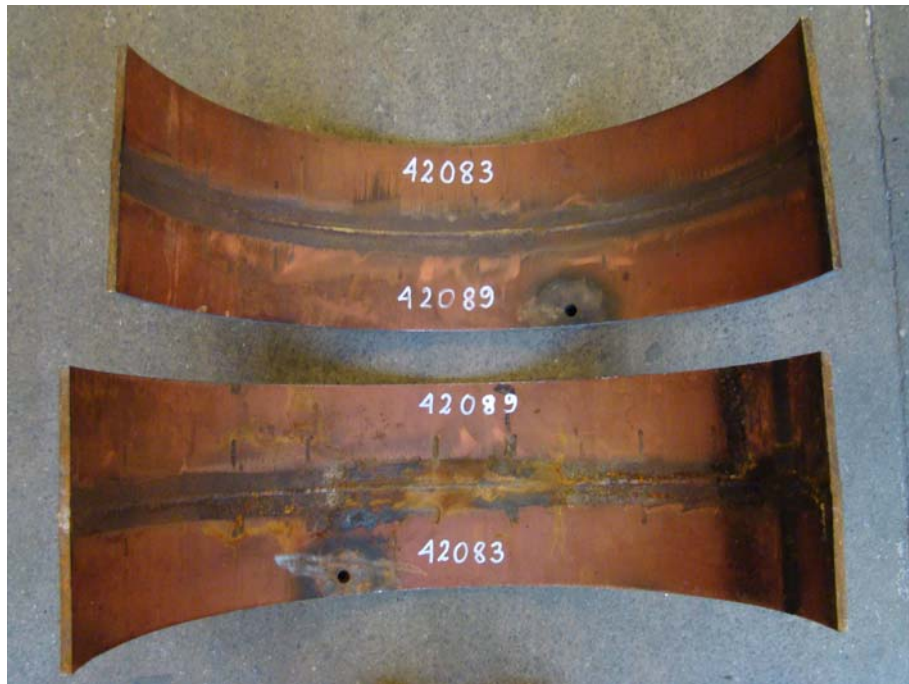
Foto nr. 4 Testrør nr. 2 efter testen.
